시험 성적서 (TEST REPORT)

성적서 번호(Report No): OT-238-RRK-018

- 기기명 (Description) : Fingerprint scanner
○ 모델명 (Model Name) : RealScan S60, RS-S60
○ 제조번호 (Serial No.) : N/A

6. 시험방법 (Test Method Used) : KS C IEC 60529:2013 / IP65

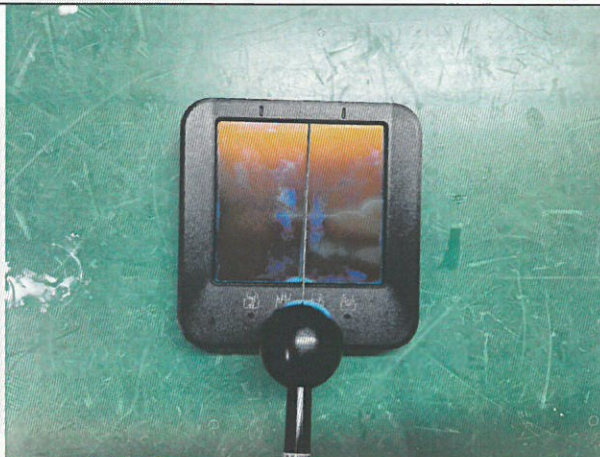
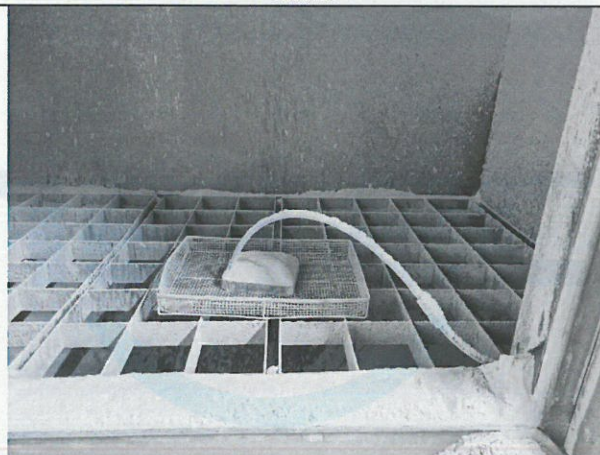
IP6X

Items	Descriptions
1 st Characteristic Numbers	6
Test Condition	- Access probes : Test wire 1.0 mm diameter, 100 mm long - Test force : $1 \text{ N} \pm 10 \%$

Items		Descriptions
1st Characteristic Numbers		6
Enclosures Category		<input checked="" type="checkbox"/> Category 1 <input type="checkbox"/> Category 2 <input type="checkbox"/> Category 1 and Category 2
Test Condition		-Wire diameter: 50 μm -Width between wires: 75 μm -Amount of talcum powder of the test chamber: 2 kg/m ³
Method	Category 1	<input type="checkbox"/> If an extraction rate of 40 to 60 volumes per hour is obtained the duration of the test is 2 h. <input checked="" type="checkbox"/> If, with a maximum depression of 2 kPa(20 mbar), the extraction rate is less than 40 volumes per hour, the test is continued until 80 volumes have been drawn, or a period of 8 h has elapsed.
	Category 2	<input type="checkbox"/> The enclosure under test is supported in its normal operating position inside the test chamber, but is not connected to a vacuum pump. Any drain-hole normally open shall be left open for the duration of the test. The test shall be continued for a period of 8 h.

EUT No.	Result
1	No pass of probe were found at any point within the enclosure

EUT No.	Result
1	No traces of dust deposits were found at any point within the enclosure
